REPORT

Galardy Technical Services Ltd.

Date: May 28, 2014 Report No.: 11988-1S

Equipment: Video Surveillance Camera

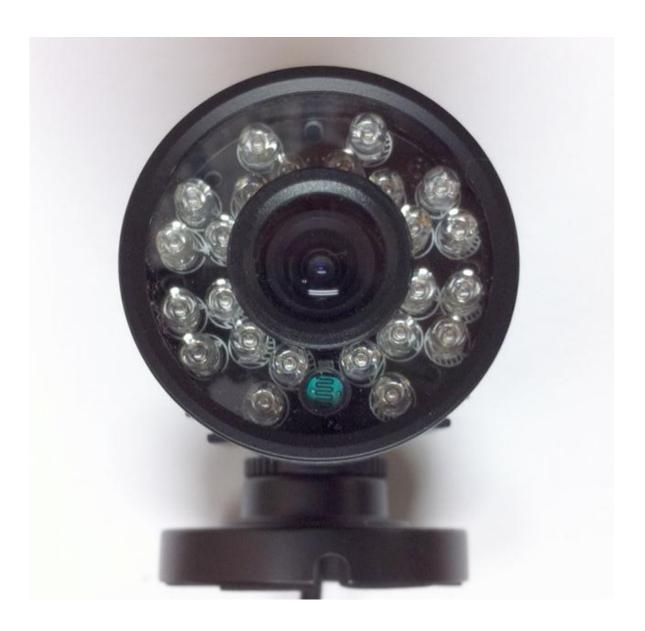
Picture 1 - GTS-CA24IR-xx Front View

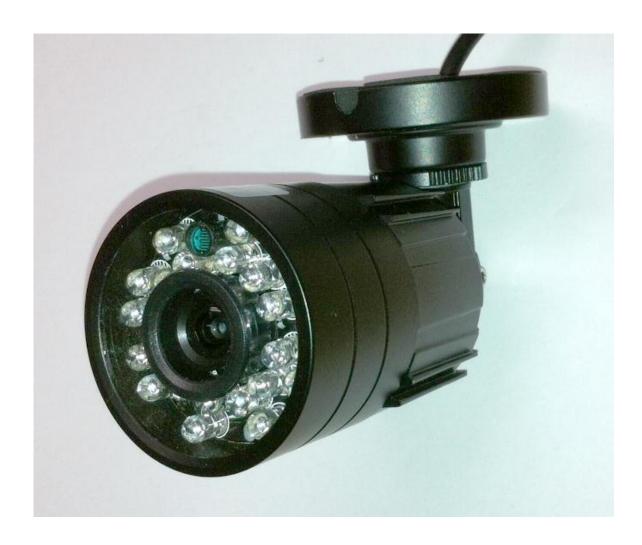
Picture 2 - GTS-CA24IR-xx Right Side View

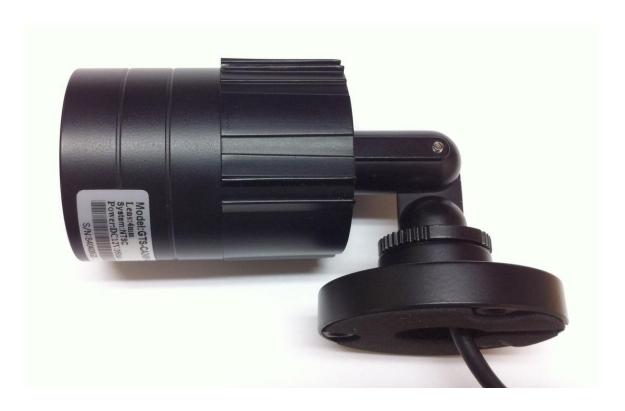
Picture 3 - GTS-CA24IR-xx Left Side View

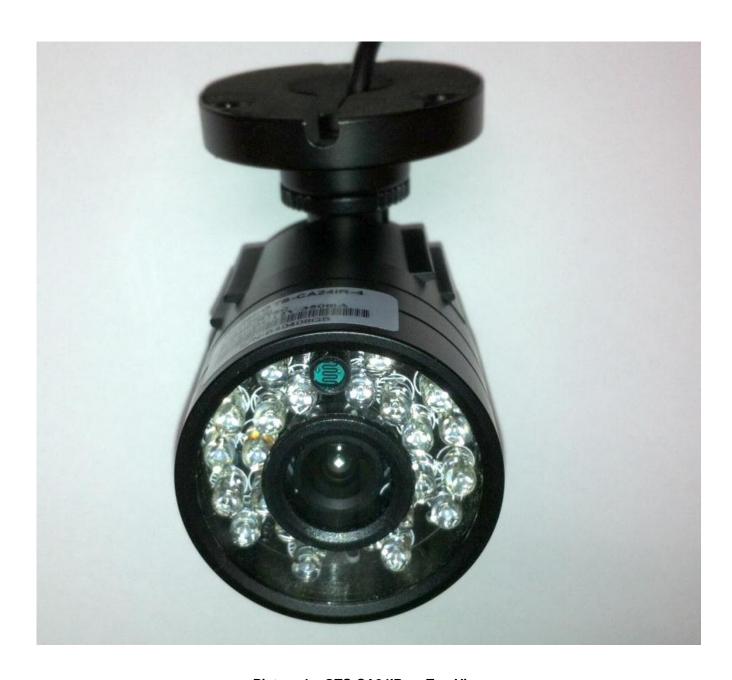
Picture 4 – GTS-CA24IR-xx Top View
